BioMax Environmental
Environmental Consulting and Industrial Hygiene Services

March 19th, 2008

Post Mitigation Assessment
Department of General Services Board of Equalization Building
10th Floor Break Room Areas
450 N. Street
Sacramento, California

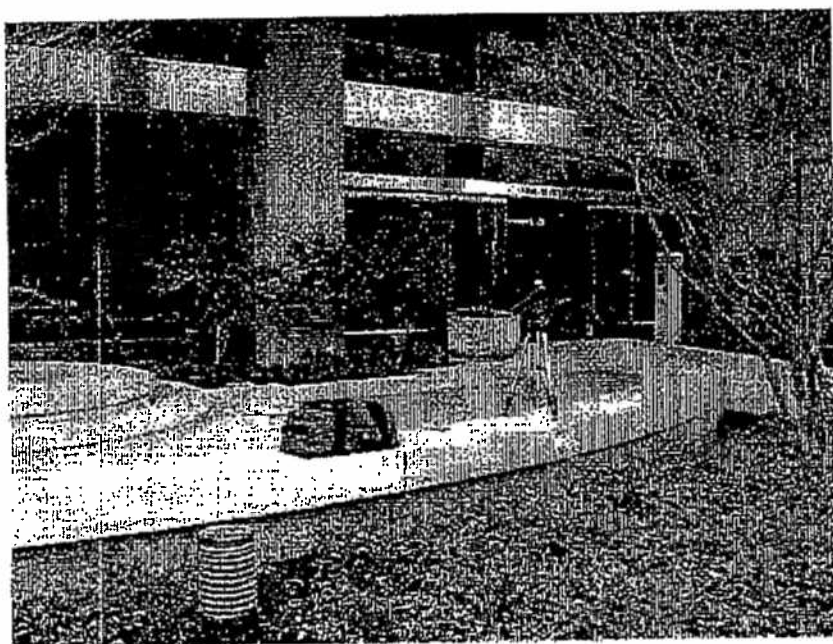
- 1) Image of ambient air sampling location at front entry of BOE Building (Subject Building) located at 450 N Street, Sacramento, California at time of assessment.

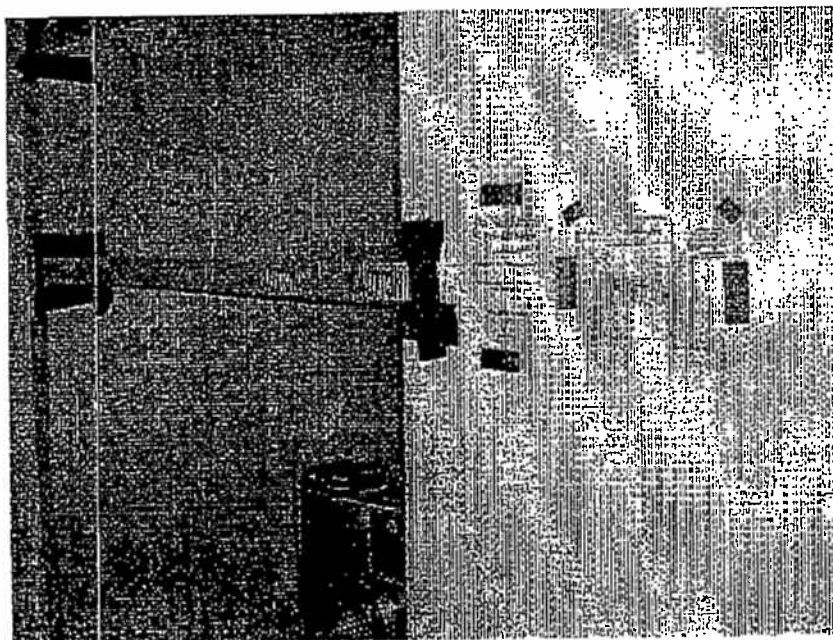
- 2) Image of postings and alternate routing directions for BOE employees at hallway leading to break room containment on the 10th floor.

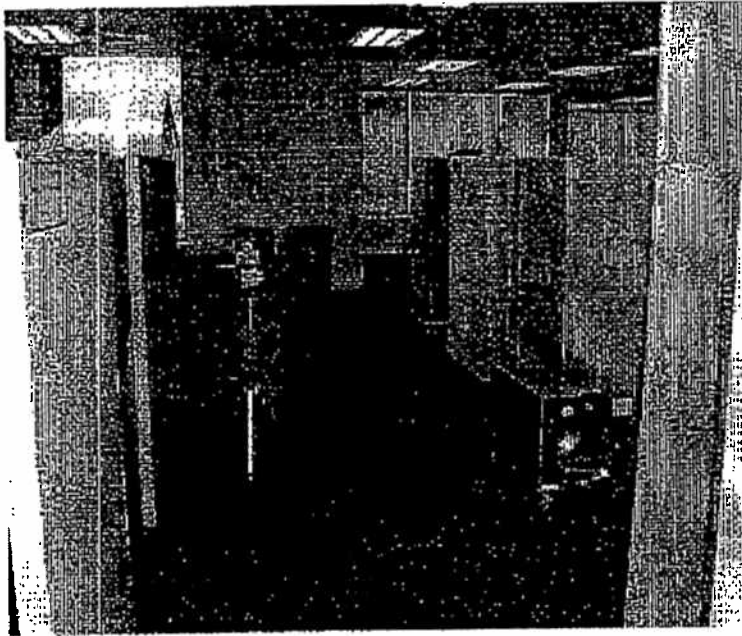
- 3) Image of cubicle work area located outside the established containment system where air sampling equipment is observed present in the foreground at time of assessment.

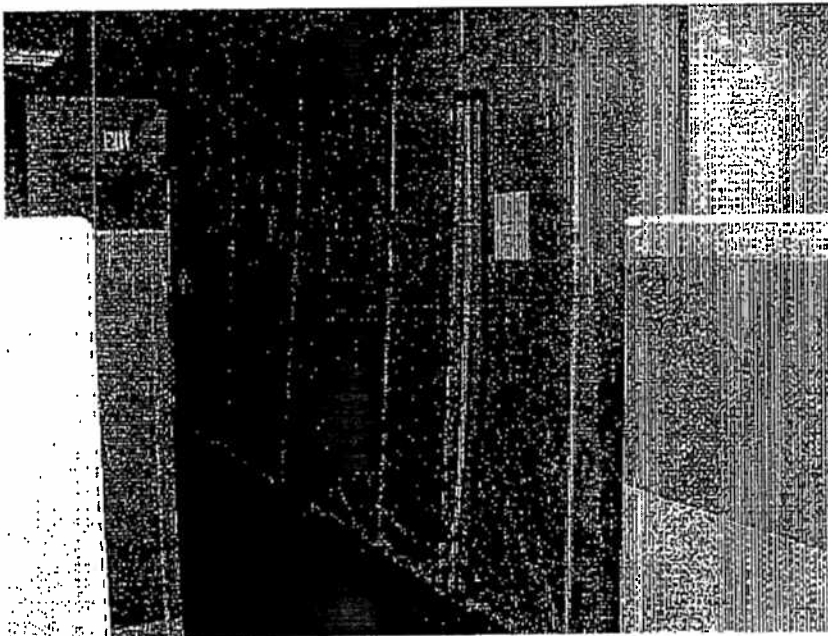
- 4) Image of hallway air sampling location adjacent to Break Room as viewed from 1014 cubicle area (outside containment) at time of assessment.

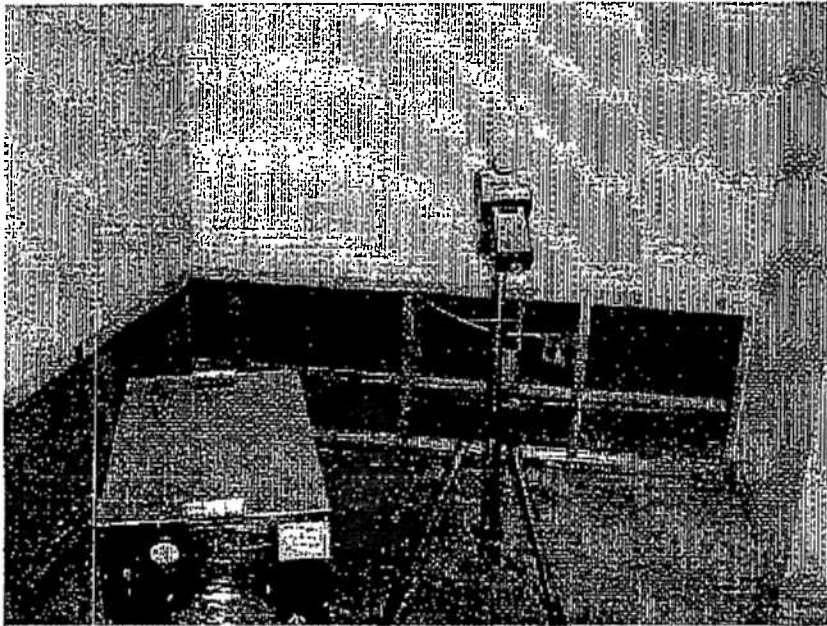
6. As proscribed, all identified affected interior wallboard building materials had been removed from each of the affected areas exposing interior wall cavity framing (metal) as well as underlayment wallboard siding materials once present within the impacted containment areas. Upon post mitigation inspection, all remaining exposed building materials associated with the interior wall systems exhibited no significant staining and/or elevated mold growth following the completion of prescribed physical mold removal and chemical decontamination procedures performed by the selected mitigation contractor on the surfaces of such exposed building materials.

- 5) Image within 10th Floor break room containment 2424 containment indicating location of air sampling equipment and extent of removal of cabinetry and wallboard materials.

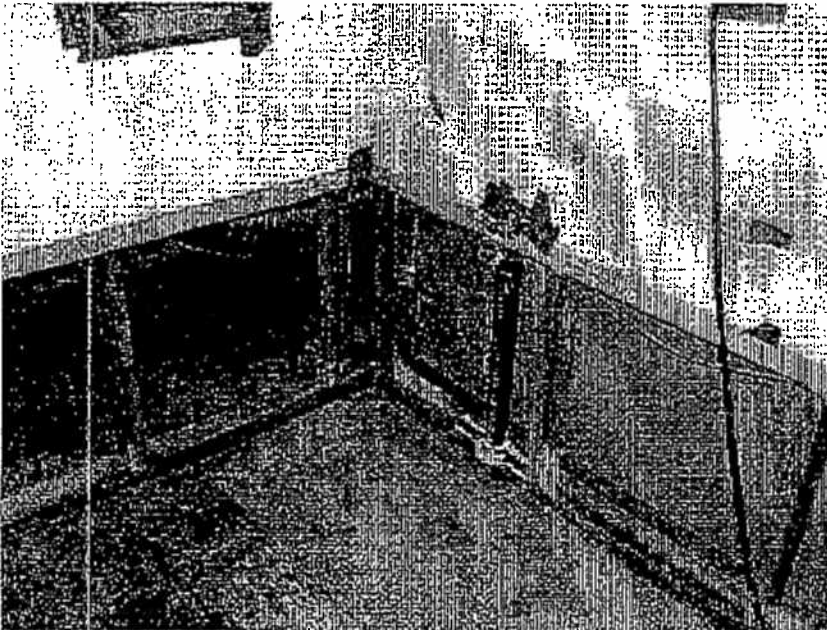
- 6) Additional image within Break Room containment area viewing corner where previous cabinetry had existed prior top removal.

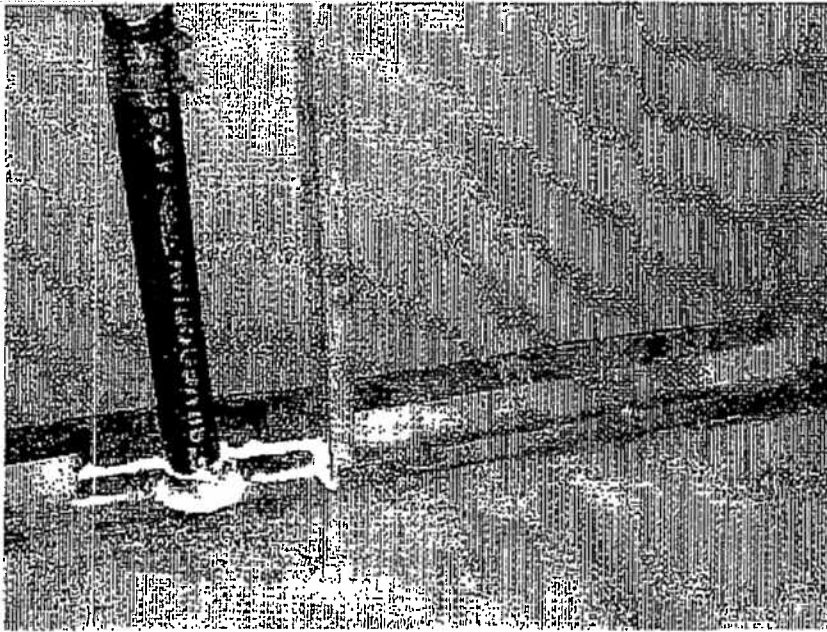
7) Close-up image within Break Room containment showing plumbing detail and wall space cavity following physical removal of damaged materials.

2. During the performance of interior reconstruction activities, BioMax recommends that a qualified and experienced building inspector/contractor be utilized to verify the current functional integrity of all applicable plumbing, flashing, sealing, and drainage systems in accordance with current building codes and construction practices. Any identified deficiencies should be appropriately documented, corrected, and then functionally verified (tested) prior to subsequent reconstruction and commercial use. Certainly, the establishment/installation of any additional engineering controls (as identified through additional professional engineering consultation) should also be performed and implemented in accordance with applicable standards, building codes, and ordinances, as necessary.

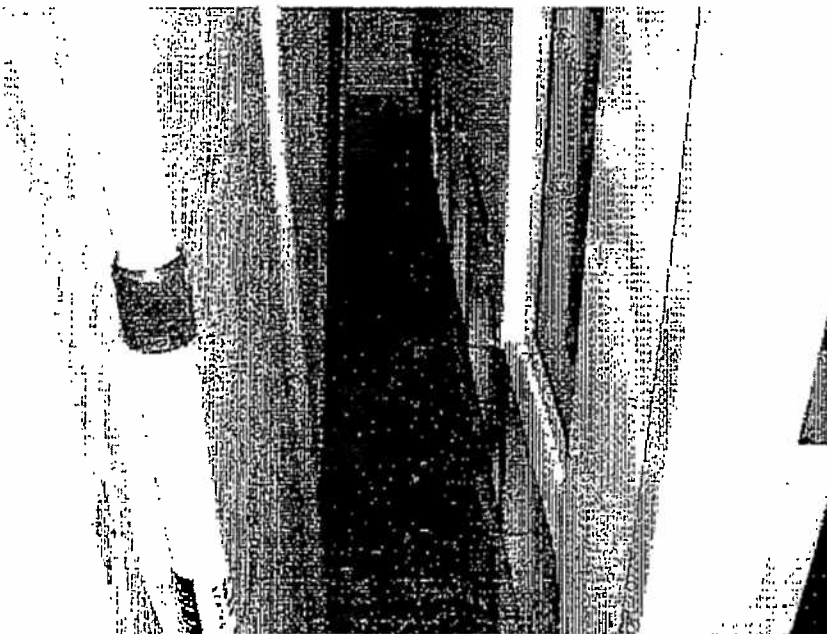
8) Image of containment space located along north facing hallway adjacent to break room and office area.

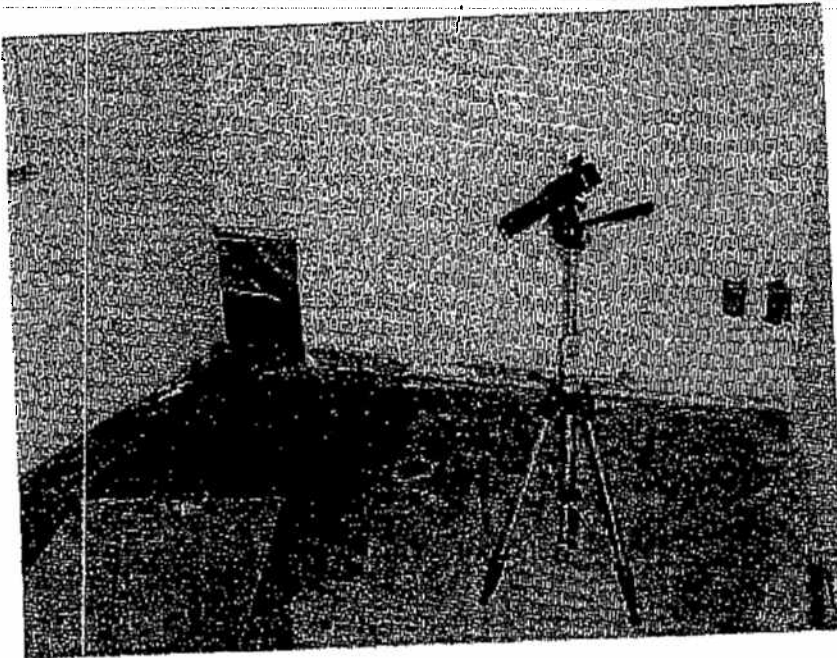
- 9) Image of air sampling equipment location within office (1003) inside containment adjacent to break room at time of assessment.

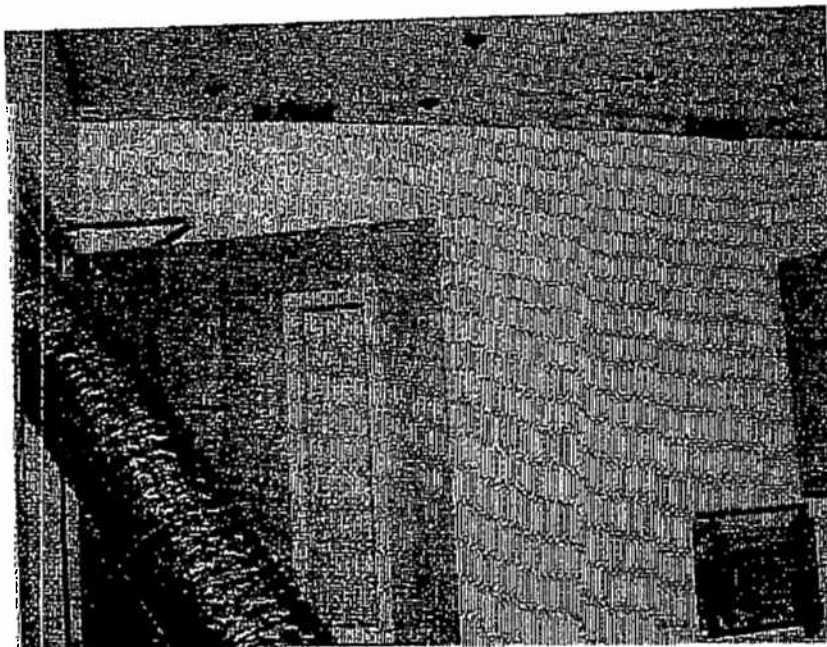
5. At the time of our post mitigation inspection, containment system encompassing each of the interior affected areas were observed and verified under appropriate posting and negative pressure differential. Worker and equipment entry and exit chambers comprised of a series of zippered plastic access doorways were also observed attached to the noted containment break room barrier consistent with BioMax's written mitigation recommendation protocols.

- 10) Image within break room containment area showing establishment of ceiling barrier and negative air exhaust ducting onto hallway.
